NASA TM X-1931

LOSS OF FORCED COOLING FLOW  
IN THE PLUM BROOK REACTOR

*by H. B. Barkley, Jr.*  
*Lewis Research Center*  
*Cleveland, Ohio*

NATIONAL AERONAUTICS AND SPACE ADMINISTRATION • WASHINGTON, D. C. • DECEMBER 1969

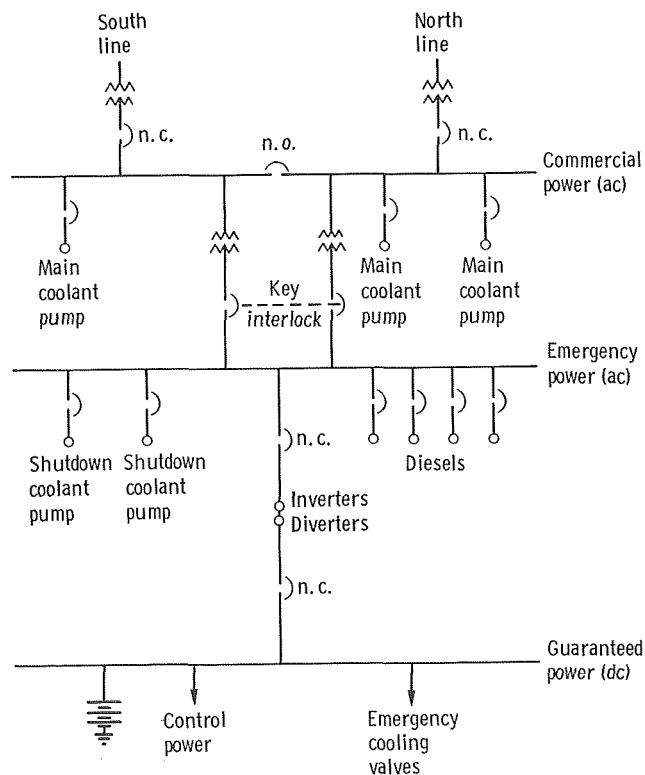
Figure 3. - Simplified electrical distribution system. (n.c., normally closed; n.o., normally open.)

Figure 3 is a simplified schematic of the portion of the electrical distribution system that concerns reactor coolant flow, at the time of the temporary loss of forced-cooling flow. (Some changes that were unrelated to the occurrence have subsequently been made.) Commercial power comes in to two buses through the "North Line" and the "South Line." These two buses are normally separated, but automatically tie together on loss of either the North or the South Line. The Emergency Power bus is normally fed through one of two breakers, from either the North or the South Commercial Power bus. A key interlock prevents both breakers from being closed simultaneously and tying the North and South Lines. Diesel generators run partly loaded on the Emergency Power bus in parallel with commercial power. On loss of commercial power, the Emergency Power bus is automatically separated from the Commercial Power bus, and the Diesels power the necessary loads. The Guaranteed Power bus is a dc bus. It is normally fed through inverters-diverters from the Emergency Power bus. Additionally, however, batteries power this bus as a backup for the unlikely loss of emergency power.

There were three design errors. (1) Too many vital control power circuits on one breaker. Dc control power to all of the main and shutdown coolant pump breakers originated from one breaker on the Guaranteed Power bus. (2) Improper breaker action on loss and restoration of breaker control power. Although the control power breaker was reclosed within a few seconds after its accidental opening, restoration of the control power did not restart any pumps. The reactor operator had to restart pumps by pressing buttons in the control room. (3) Inadequate physical protection for the breaker handles on some vital breakers. This single vital control power breaker handle had no physical protection covering it to prevent inadvertent operation.

As a result of the review and evaluation occasioned by the loss of forced cooling flow occurrence, we took the following actions. The dc control power for the three main and two shutdown coolant pumps was rewired so that each pump breaker and the automatic switching circuitry received control power through separate breakers. We separated the ac feed of the two shutdown coolant pumps so that they were not both fed from a single breaker. We provided for automatic restart of the shutdown coolant pumps when power is restored. The dc control and operator power sources for each of the emergency coolant valves were combined, and each of these valves was supplied from a separate breaker. All vital circuit breakers were provided with physical protection to prevent inadvertent tripping. A single switch was installed on the control room console to activate all of the valves required for emergency cooling. A flow limiting orifice was installed downstream of the reactor tank drain valve to automatically limit the flow of emergency cooling water, avoiding the need to open the drain valve a specified amount. The control room annunciator windows for "primary main flow off-normal" and the "primary shutdown flow off-normal" were outlined in red to make them stand out from the other alarms. We ran several additional drills for each shift team to insure that all personnel recognize and know what to do if emergency cooling should become necessary or other abnormalities occur in the relatively few fundamental elements of reactor safety. We discussed with all reactor operators the circumstances and potential consequences of this occurrence.
